# Influence of lay-up configuration and feed rate on surface integrity when drilling carbon fibre reinforced plastic (CFRP) composites

2<sup>nd</sup> CIRP Conference on Surface Integrity (CSI)

Experimental data is presented relating to surface roughness (2D and 3D) and workpiece integrity when drilling unidirectional CFRP laminates with varying lay-up configurations (Type 1, 2 and 3) at different feed rates (0.2 and 0.4mm/rev) using diamond coated carbide tools. Drill feed rate was ramped down to 0.01mm/rev for the final 0.5mm in all trials. Surface roughness at hole exit was typically lower (up to 4.04µm Ra) compared with the entry section in all tests due to the lower feed rate applied. High resolution SEM micrographs and 3D topographic maps showed that Type 2 ([45/0/135/0/90/0/135/0/45]<sub>2S</sub>) lay-up gave the lowest roughness of ~1.16µm Sa after 384 holes at a cutting speed and feed rate of 90m/min and 0.4mm/rev respectively. Cavities, smearing of matrix material and adhered/deposited fibre dust were observed near the exit location at test cessation.

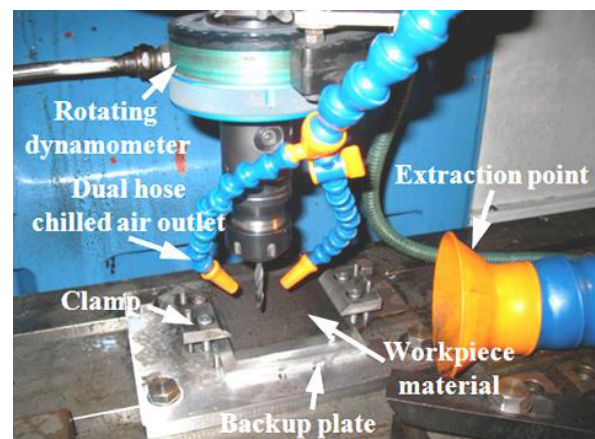
Fig. 2. Drilling experimental setup

All tests were carried out on a Matsuura FX-5 vertical high speed CNC machining centre with a variable spindle capable of up to 20,000rpm rated at 15kW. The machine was fitted with a Filtermist dust extraction system for removing airborne CFRP dust particles  $\geq 0.3\mu\text{m}$ . A chilled air environment ( $\sim 8^\circ\text{C}$ ) was utilised in each trial and was generated using a Nex-Flow vortex tube (type 56030FD), which was directed to the cutting zone through two adjustable nozzle hoses at a pressure

of 0.4 bar. The CFRP workpieces for tool wear/life testing were held in a bespoke drilling jig with an array (10×10) of pre-fabricated 7mm diameter clearance holes, see Fig. 2 for experimental setup.

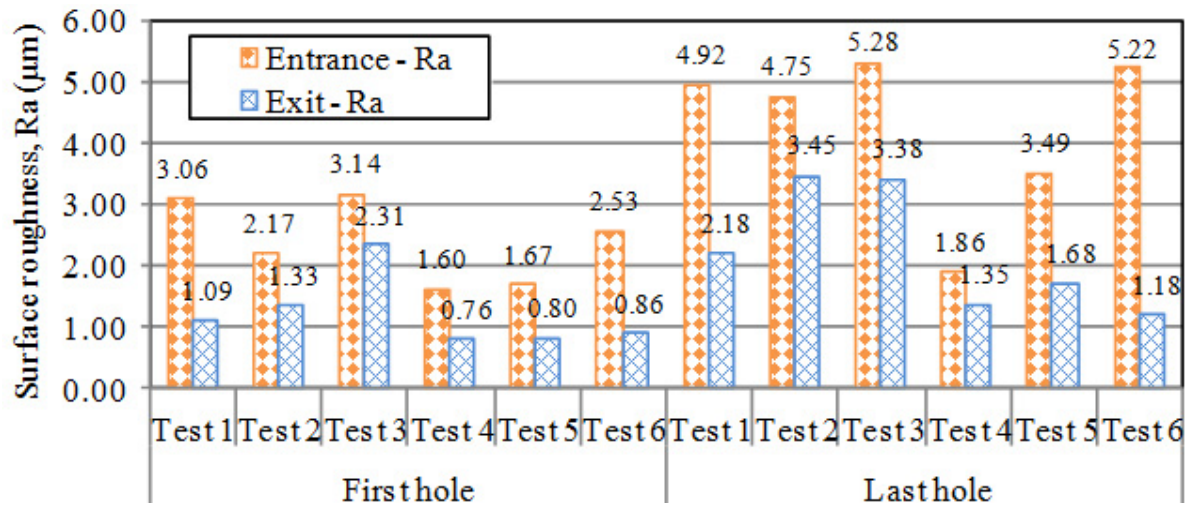
Fig. 5. Surface roughness (Ra) results for all tests at entrance and exit location for the first and last hole

Fig. 5 details surface roughness ( $R_a$ ) values measured at the entry and exit positions in both the first and last holes drilled for all tests. Hole roughness was generally higher in Type 3 workpieces (Tests 3 and 6) at both feed rate levels, which was due to the larger number of plies (14) orientated at 135°. Increasing feed rate from 0.2 to 0.4mm/rev led to lower  $R_a$  in all of the samples analysed, which was attributed to a decrease in tool wear when operating at higher feed rates, as a result of the shorter interaction period between the tool and workpiece [6]. Furthermore, the  $R_a$  measured in the vicinity of the hole exit location was consistently found to be lower (by up to ~80%) compared to the entrance section, which was possibly due to a 'ploughing' or 'polishing' effect when operating at the very low feed rate of 0.01mm/rev. An analysis of skewness ( $R_{sk}$ ) showed that all values were negative, indicating that the machined surfaces were typically dominated by sharp/deep valleys, most likely the result of fibre pull out/matrix loss. Conversely, the relatively high kurtosis ( $R_{ku}$ ) values recorded ( $> 3$ ) suggests the presence of sharp peaks on the measured profiles, which was likely from uncut/re-deposited fibres on the hole surfaces.

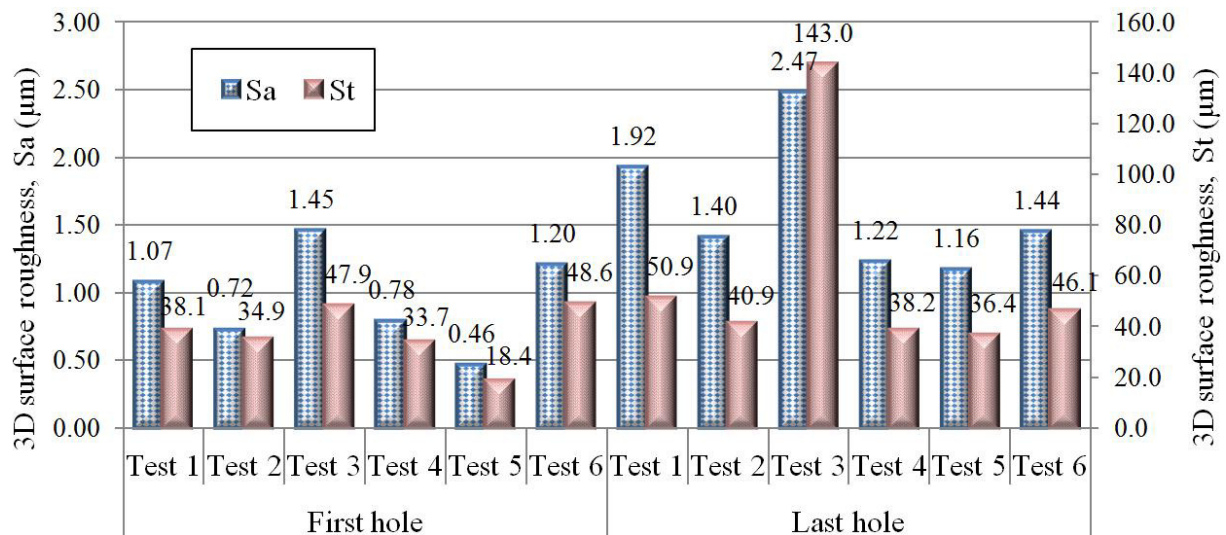
Fig. 6. Surface roughness ( $S_a$  and  $S_t$ ) results for first and last holes in all tests

Fig. 6 details the measured 3D roughness parameters ( $S_a$  and  $S_t$ ) for the first and last holes drilled in each of the experiments (all tests drilled 384 holes). The trends were largely similar to corresponding Ra data with hole surface quality generally deteriorating as tool wear increased (up to  $\sim 150\%$  higher  $S_a$  value at test cessation in Test 5) and when operating at the lower feed rate level (deviation of  $\sim 21 - 72\%$ ). In terms of CFRP lay-up configuration, the Type 2 material was found to give the lowest roughness with minimum  $S_a$  values of 0.46 and  $1.16\mu\text{m}$  when utilising new and worn tools respectively in Test 5. An analysis of variance (ANOVA) showed that both workpiece material and feed rate were statistically significant at the 5% level with respect to  $S_a$ ,

lay-up having the greater effect with a percentage contribution ratio (PCR) of 83.7% compared to only 16.2% for feed rate. In addition, the variation in  $S_t$  (total height of the surface) was similar to that of the  $S_a$  parameter with a maximum of  $143.0\mu\text{m}$  for the last hole in Test 3.

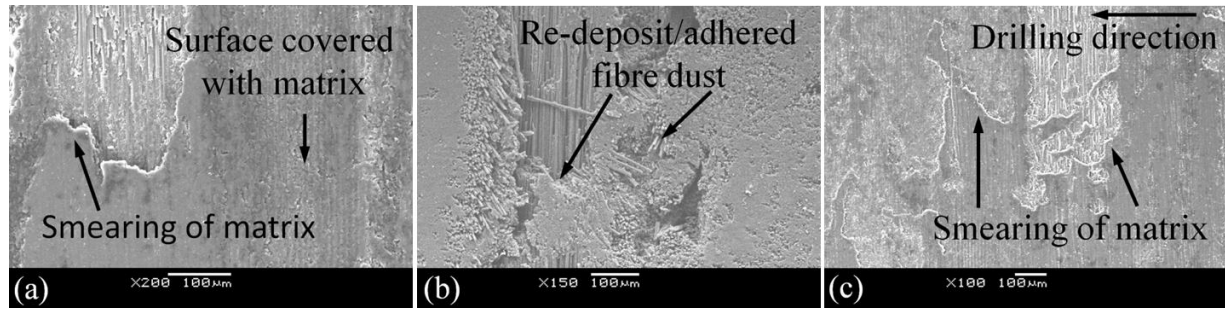
Fig. 9. SEM micrographs showing surfaces near the exit location in (a) Test 1 - hole 1; (b) Test 1 - hole 384; (c) Test 5 - hole 1

Fig. 9 shows sample SEM micrographs of surfaces near the hole exit location (drilled at feed rate of 0.01mm/rev). Observations showed that smearing of melted matrix material was prevalent when drilling with new tools. This was possibly due to the increased tool-workpiece contact time at the low feed rate resulting in relatively higher interface temperatures. The poor thermal conductivity of CFRP was a further contributory factor in relation to resin melt, which typically occurs at 300 - 400°C [12]. Conversely, adhered or re-deposited fibre dust and fibre/matrix cracking similar to that shown in Fig. 9(b) was evident as tool wear increased, with severity highly dependent on ply orientation and drill edge sharpness.
